UNITED STATES ENVIRONMENTAL PROTECTION AGENCY
REGION 5
77 WEST JACKSON BOULEVARD
CHICAGO, IL 60604

SUBJECT: Clean Air Act Inspection at Duke Zimmer Station – Moscow, Ohio

Date of Inspection October 1, 2014

To determine compliance with the Clean Air Act and conduct Method 9 opacity readings on the main boiler stack.

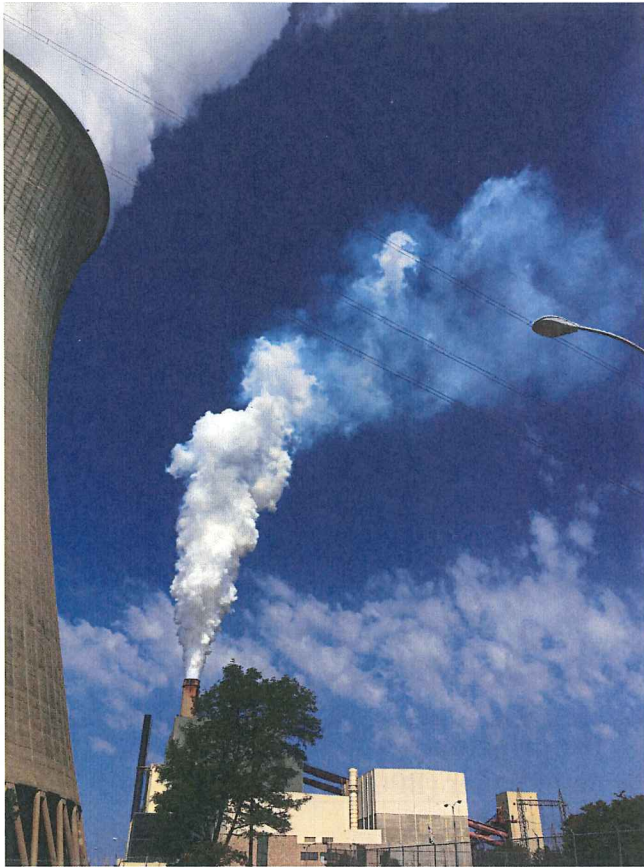
Photo No.	Date and Time:	Description:
IMG_0313	Oct 1, 2014 at 1:59 PM	Main Boiler (B006) Plume

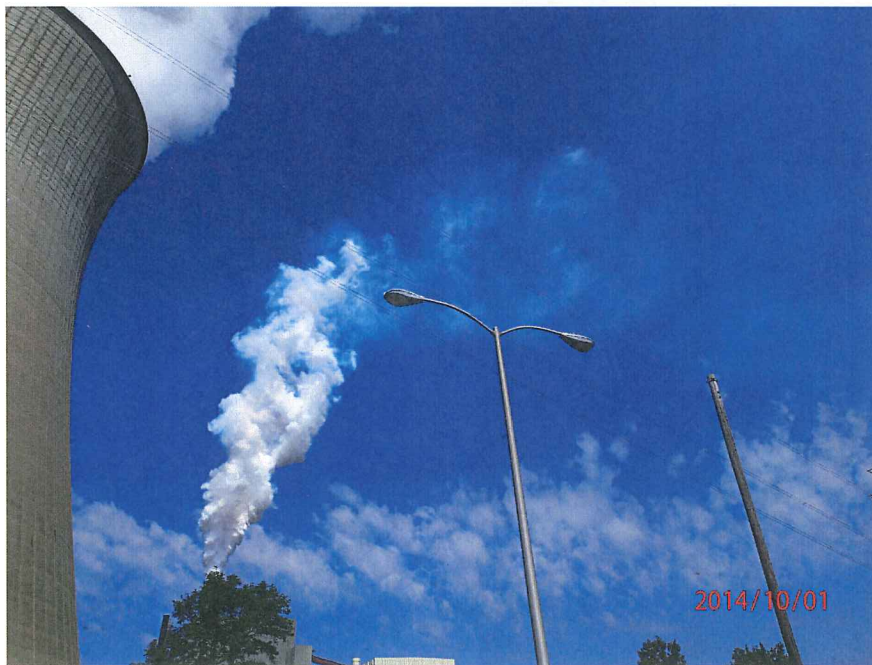
Photo No.	Date and Time:	Description:
PA010021	Oct 1, 2014 at 1:59 PM	Main Boiler (B006) Plume

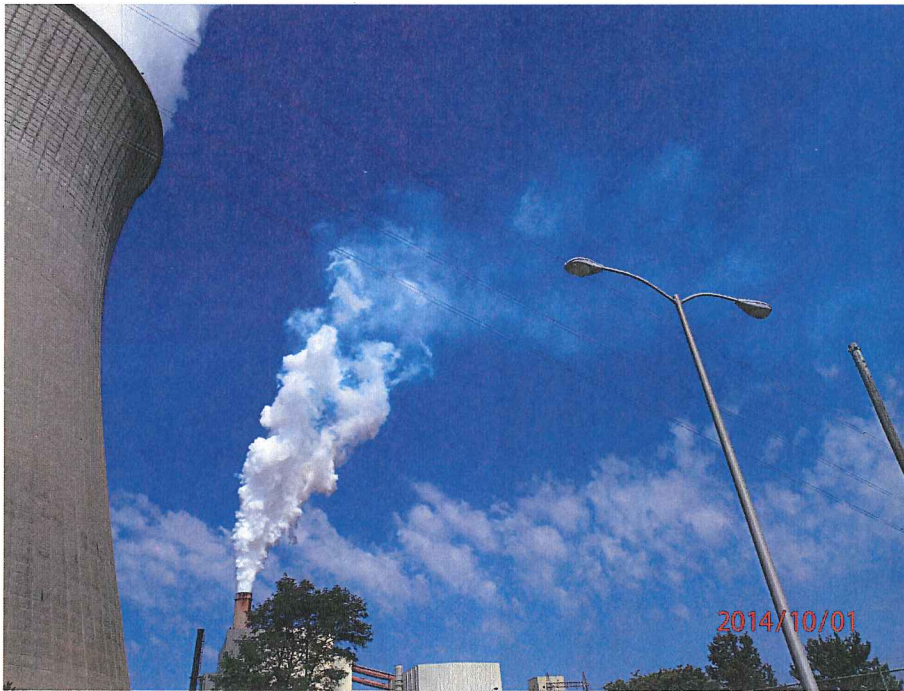
Photo No.	Date and Time:	Description:
PA010022	Oct 1, 2014 at 2:00 PM	Main Boiler (B006) Plume

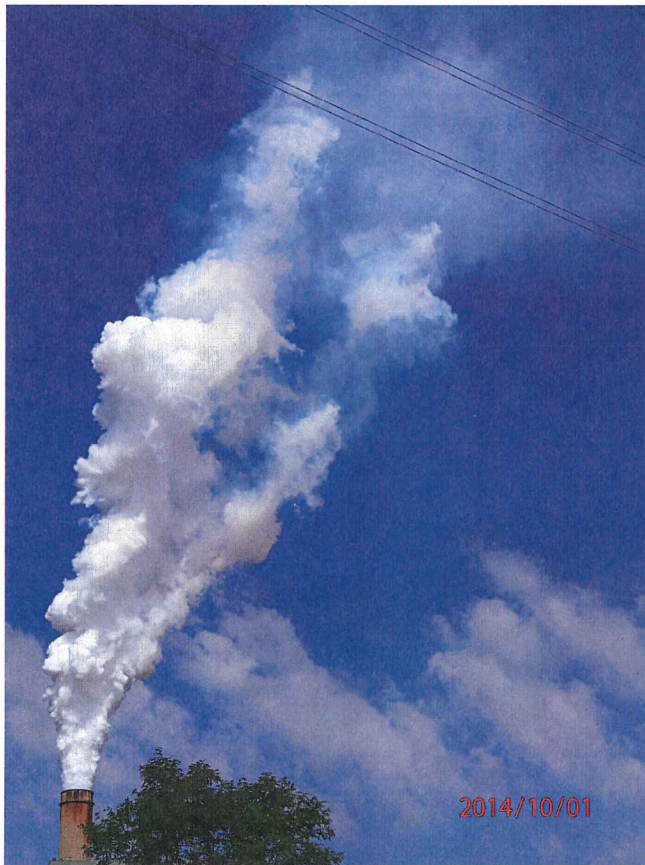
Photo No.	Date and Time:	Description:
PA010023	Oct 1, 2014 at 2:00 PM	Main Boiler (B006) Plume

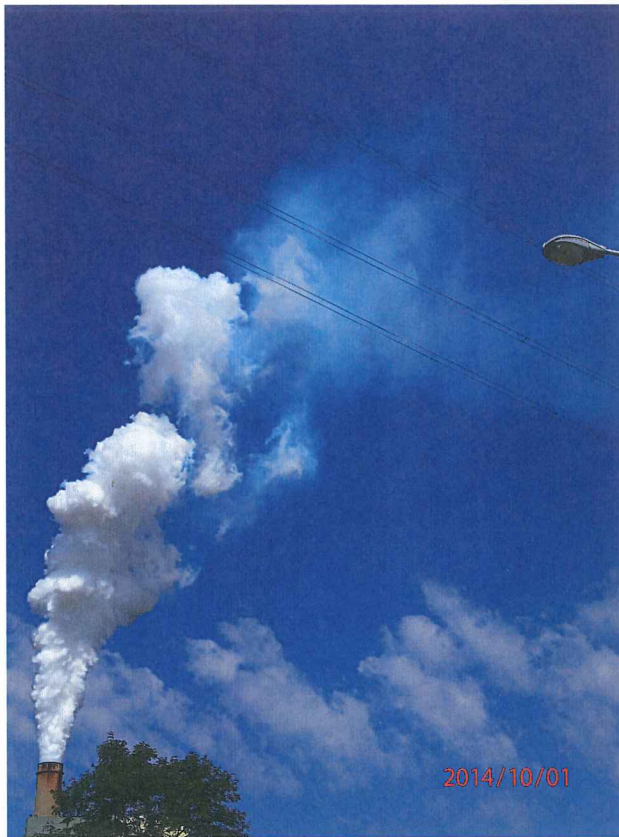
Photo No. PA010024	Date and Time: Oct 1, 2014 at 2:00 PM	Description: Main Boiler (B006) Plume
------------------------------	---	---

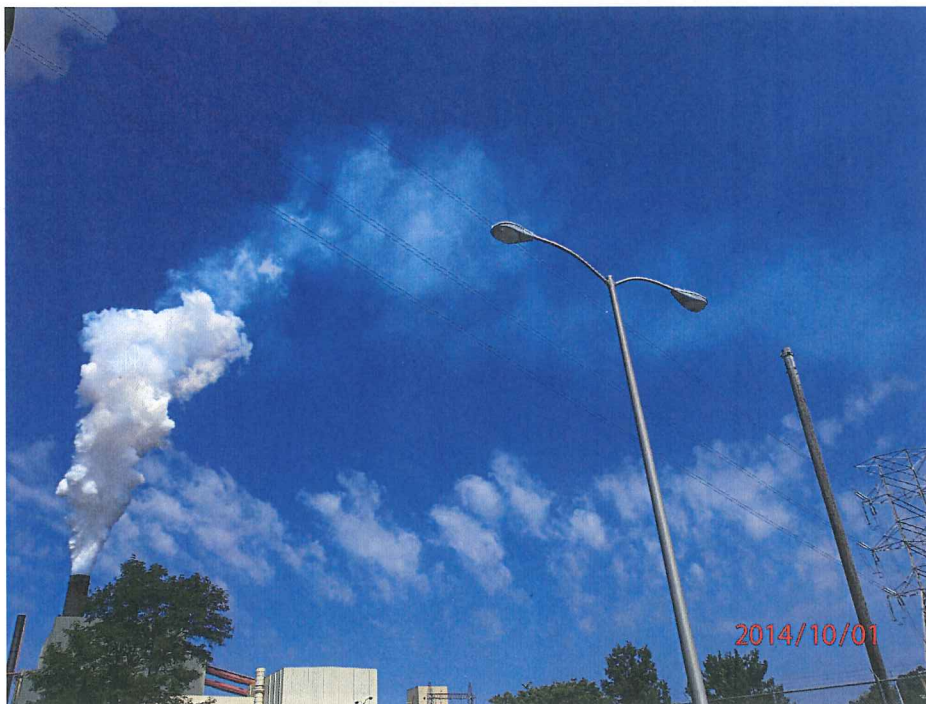
Photo No. PA010026	Date and Time: Oct 1, 2014 at 2:01 PM	Description: Main Boiler (B006) Plume
------------------------------	---	---

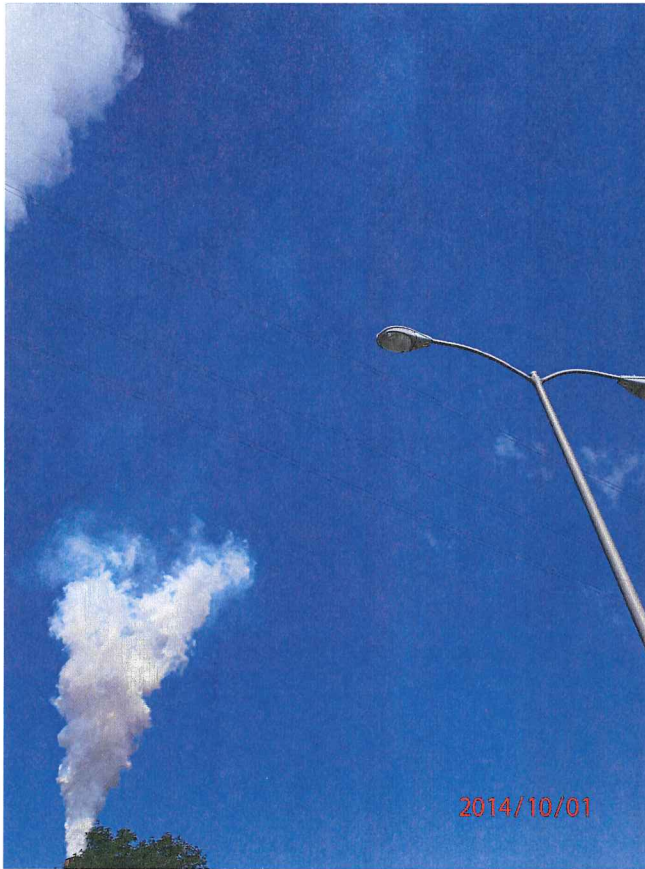
Photo No. PA010032	Date and Time: Oct 1, 2014 at 2:14 PM	Description: Main Boiler (B006) Plume
------------------------------	---	---

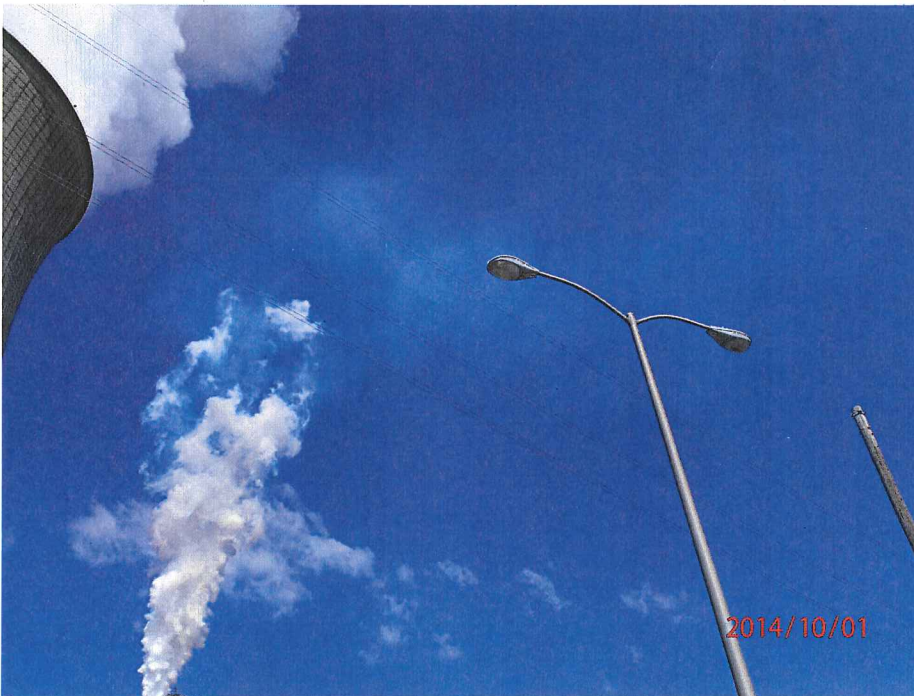
Photo No. PA010033	Date and Time: Oct 1, 2014 at 2:21 PM	Description: Main Boiler (B006) Plume
------------------------------	---	---

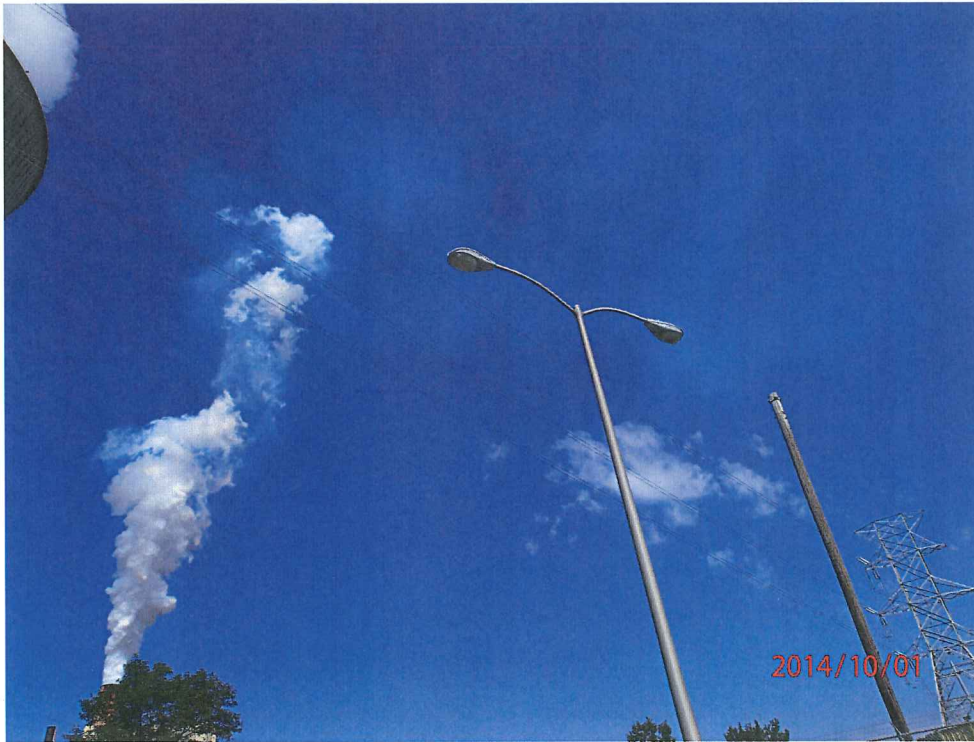
Photo No. PA010034	Date and Time: Oct 1, 2014 at 2:25 PM	Description: Main Boiler (B006) Plume
------------------------------	---	---

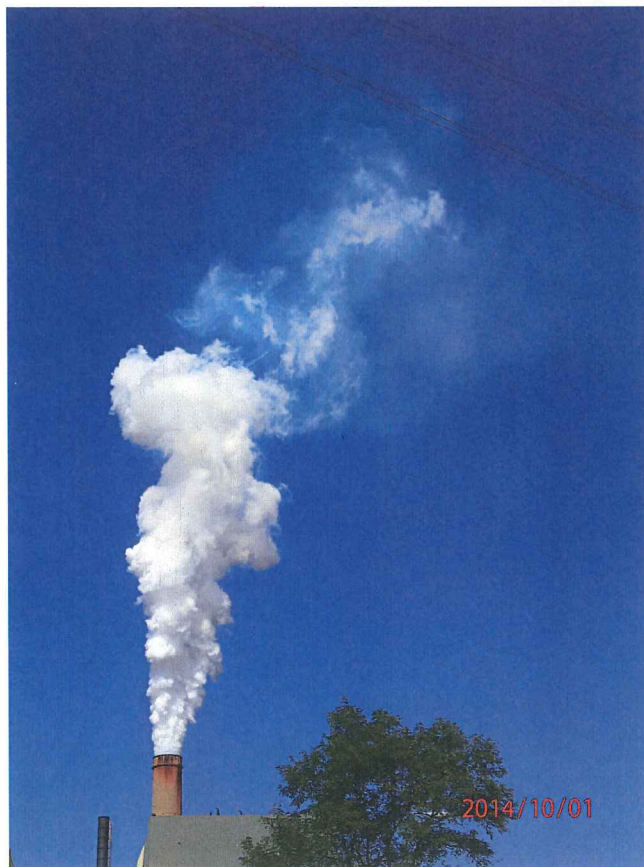
Photo No. PA010035	Date and Time: Oct 1, 2014 at 2:31 PM	Description: Main Boiler (B006) Plume
------------------------------	---	---

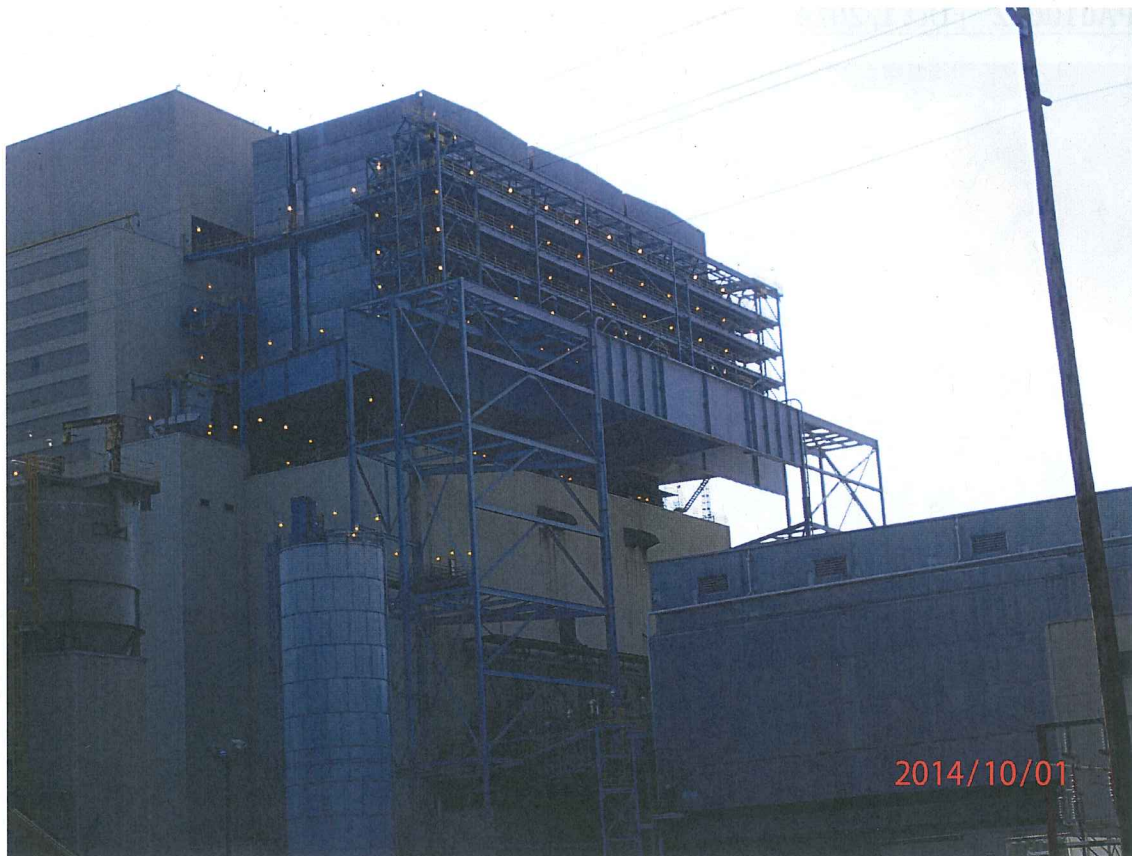
Photo No. PA010041	Date and Time: Oct 1, 2014 at 4:08 PM	Description: SCRs on top and air heaters on bottom
------------------------------	---	--

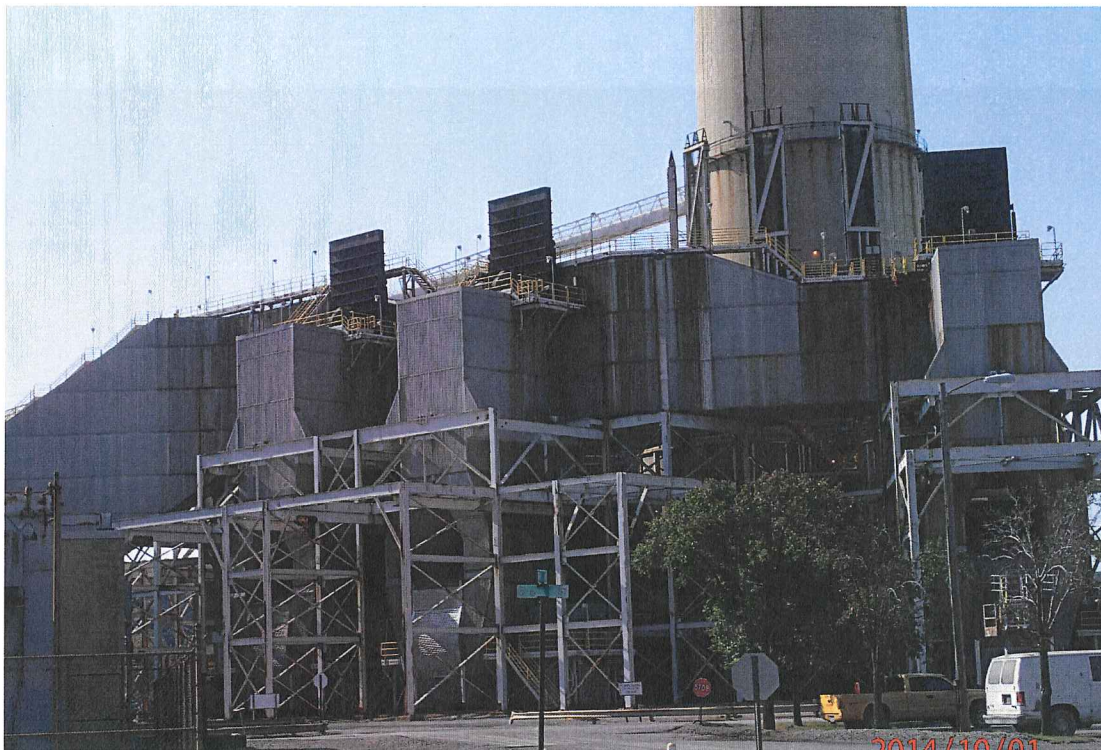
Photo No. PA010042	Date and Time: Oct 1, 2014 at 4:09 PM	Description: FGD Modules surrounding stack
------------------------------	---	--

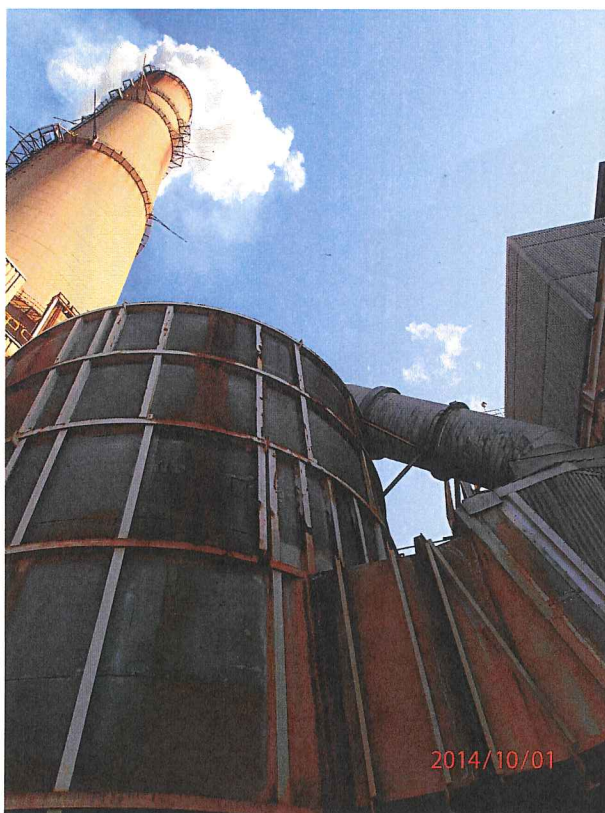
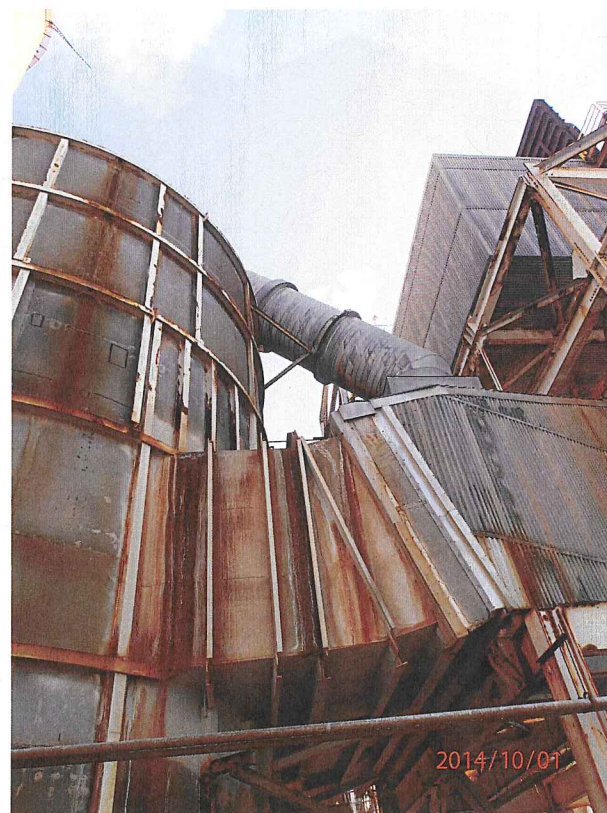
Mr. Rohrer confirmed that Duke modified the FGD in 2005/6 during which time they blocked the bypass dampers on all of the FGD modules, increased the absorber recirculation pump capacity, and changed the tray and spray configurations. Mr. Chatfield asked why EPA is not seeing a marked increase in SO₂ removal. Mr. Rohrer explained that the FGD was upgraded for a 96% removal, but ended up achieving removal rates in the high 95s. The plant strives to achieve an average of 92.5% to ensure compliance. Mr. Chatfield further questioned as to why removal rates during startup are so poor if there is no longer any bypassing. Mr. Rohrer explained that it often takes time to "get the chemistry up" during the first 24 hours after the unit comes online. The scrubber liquid is 'diluted' when the unit is shut down and it takes time to get the magnesium levels in the water high enough. Mr. Rohrer explained that if their removal rate drops below 25% when starting up then they are forced to take the unit back offline. They could truck in some synthetic magnesium and spike the scrubber liquid, but that would/could be costly and therefore is not done. Mr. Rohrer stated that the plant is still in startup and there is no ammonia flow and hence higher opacity. Mr. Rohrer stated that a contractor, working Monday thru Friday tells Duke which injection port to inject the sorbent for SO₃ removal. Duke usually starts up with 4 of the 6 scrubber modules, then adds one additional module during full load operation. There is usually one module down for service at all times.

Photo No. PA010044&5	Date and Time: Oct 1, 2014 at 4:29 PM	Description: Location of old bypass, blocked now
--------------------------------	---	--

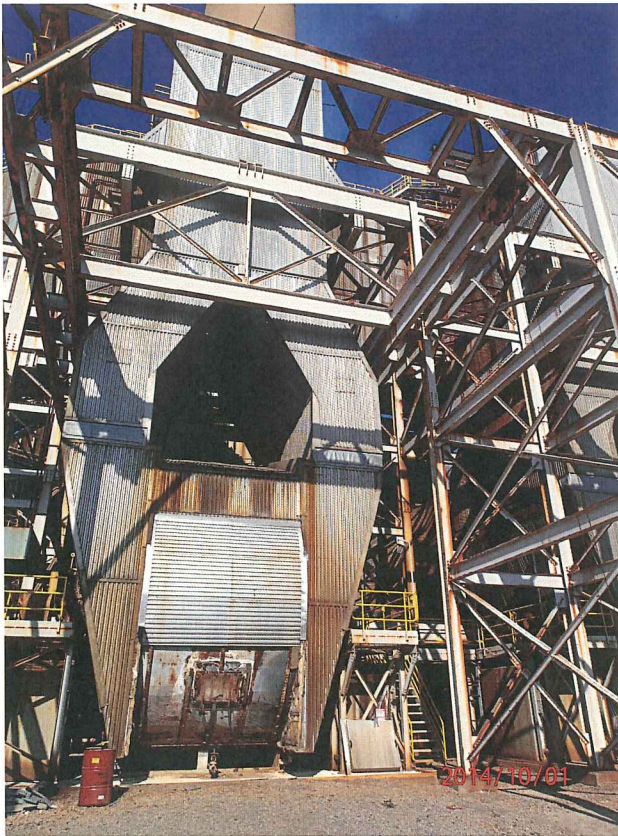
Photo No. PA010046	Date and Time: Oct 1, 2014 at 4:31 PM	Description: FGD Module
------------------------------	---	-----------------------------------

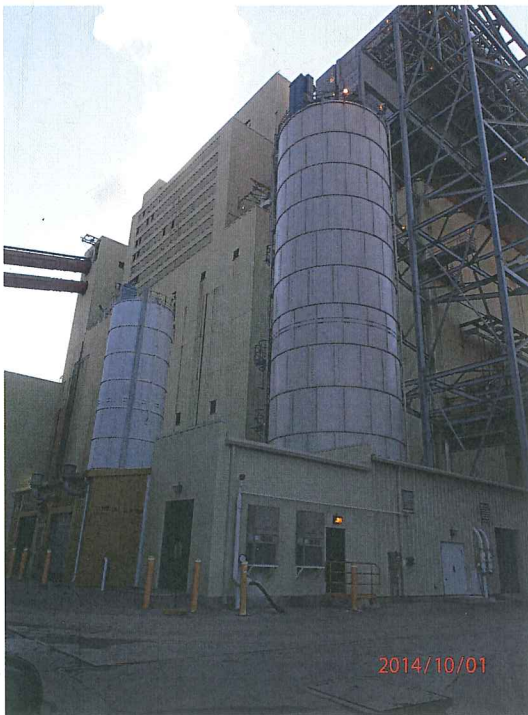
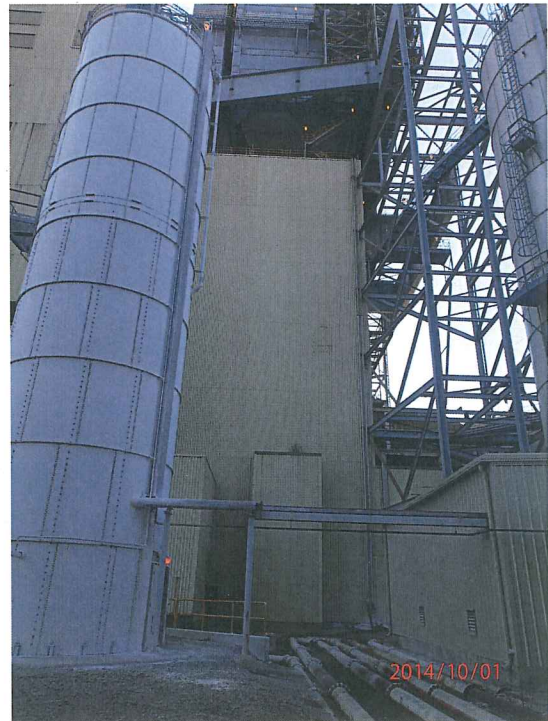
Duke staff and EPA inspectors walked the perimeter of the FGD modules and returned to the truck due to lack of time. On the way back to the office Mr. Lauer noted the hydrated lime silos and the injection system on the side of building (see Attachment 2 Photos).

Photo No. PA010048&9	Date and Time: Oct 1, 2014 at 4:37 PM	Description: SO ₃ Mitigation System (sorbent silos)
--------------------------------	---	--
